Ms 6.9 Negros Oriental Earthquake

PHIVOLCS QUICK RESPONSE TEAM

Geologic Impacts of the 06 February 2012
Negros Oriental Earthquake in
Negros and Cebu Islands

REPORT OF INVESTIGATION

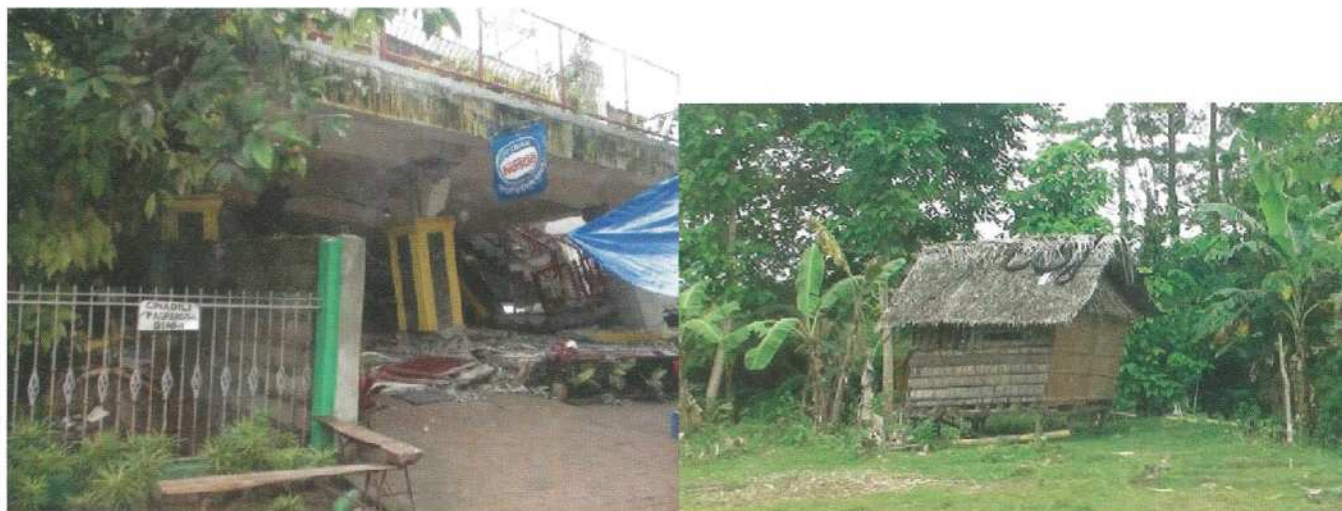
Figure 5. Left: Two-storey reinforced concrete collapse due to ground shaking. Right: A traditional house that swayed to the direction of the shaking.

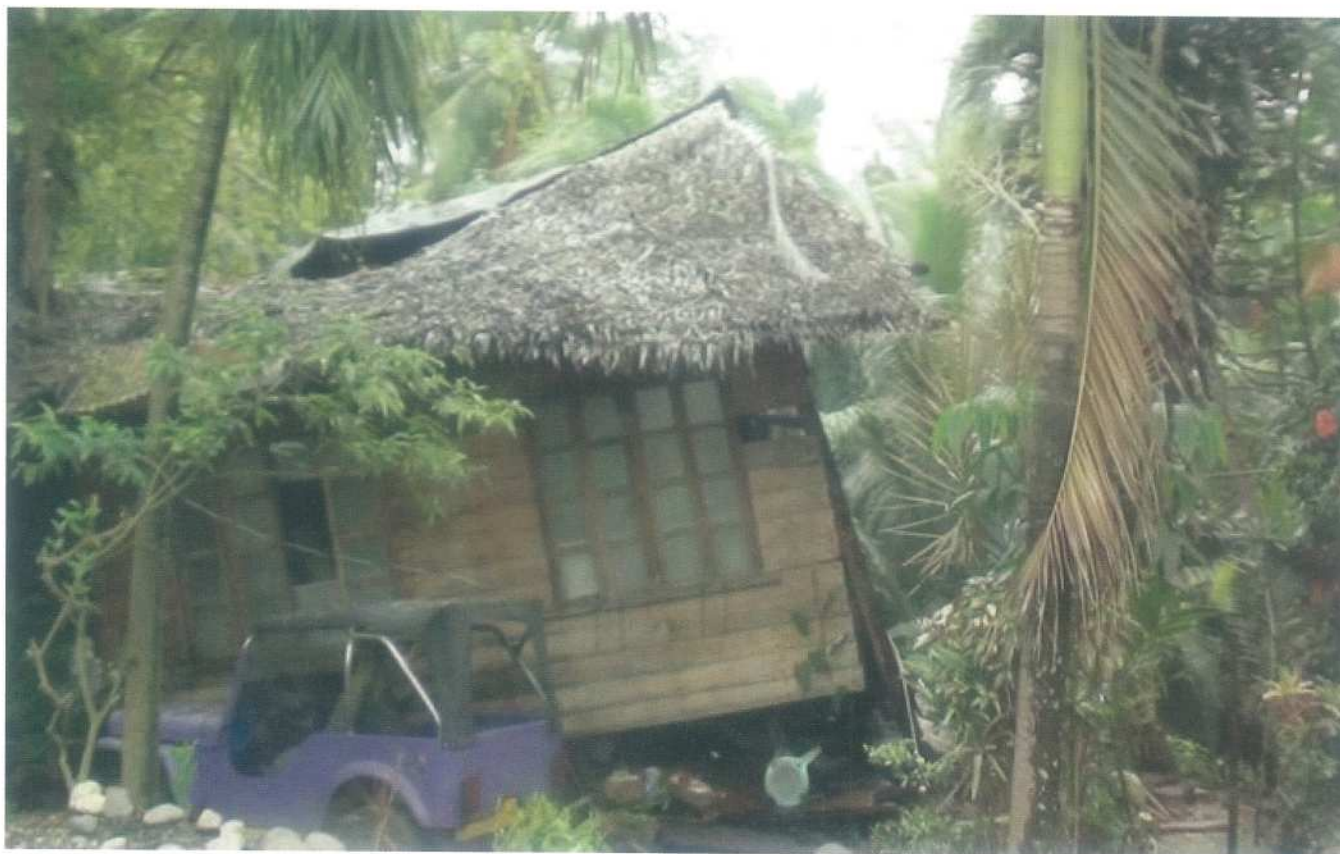
Figure 6. Wooden post failure due to severe shaking.

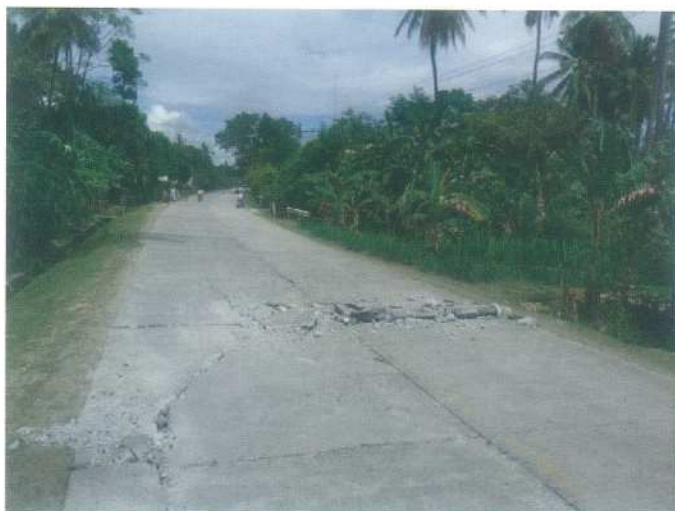
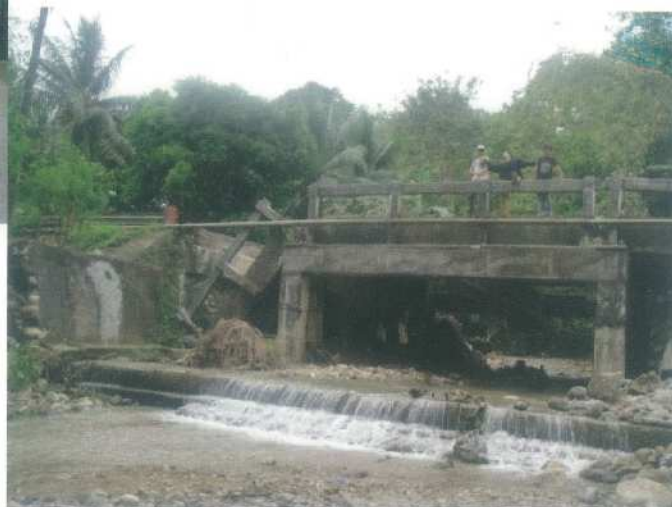
Figure 7. Above: Ruptured concrete of a national highway section. Right: Span collapse of Martilo Bridge at La Libertad Municipality.

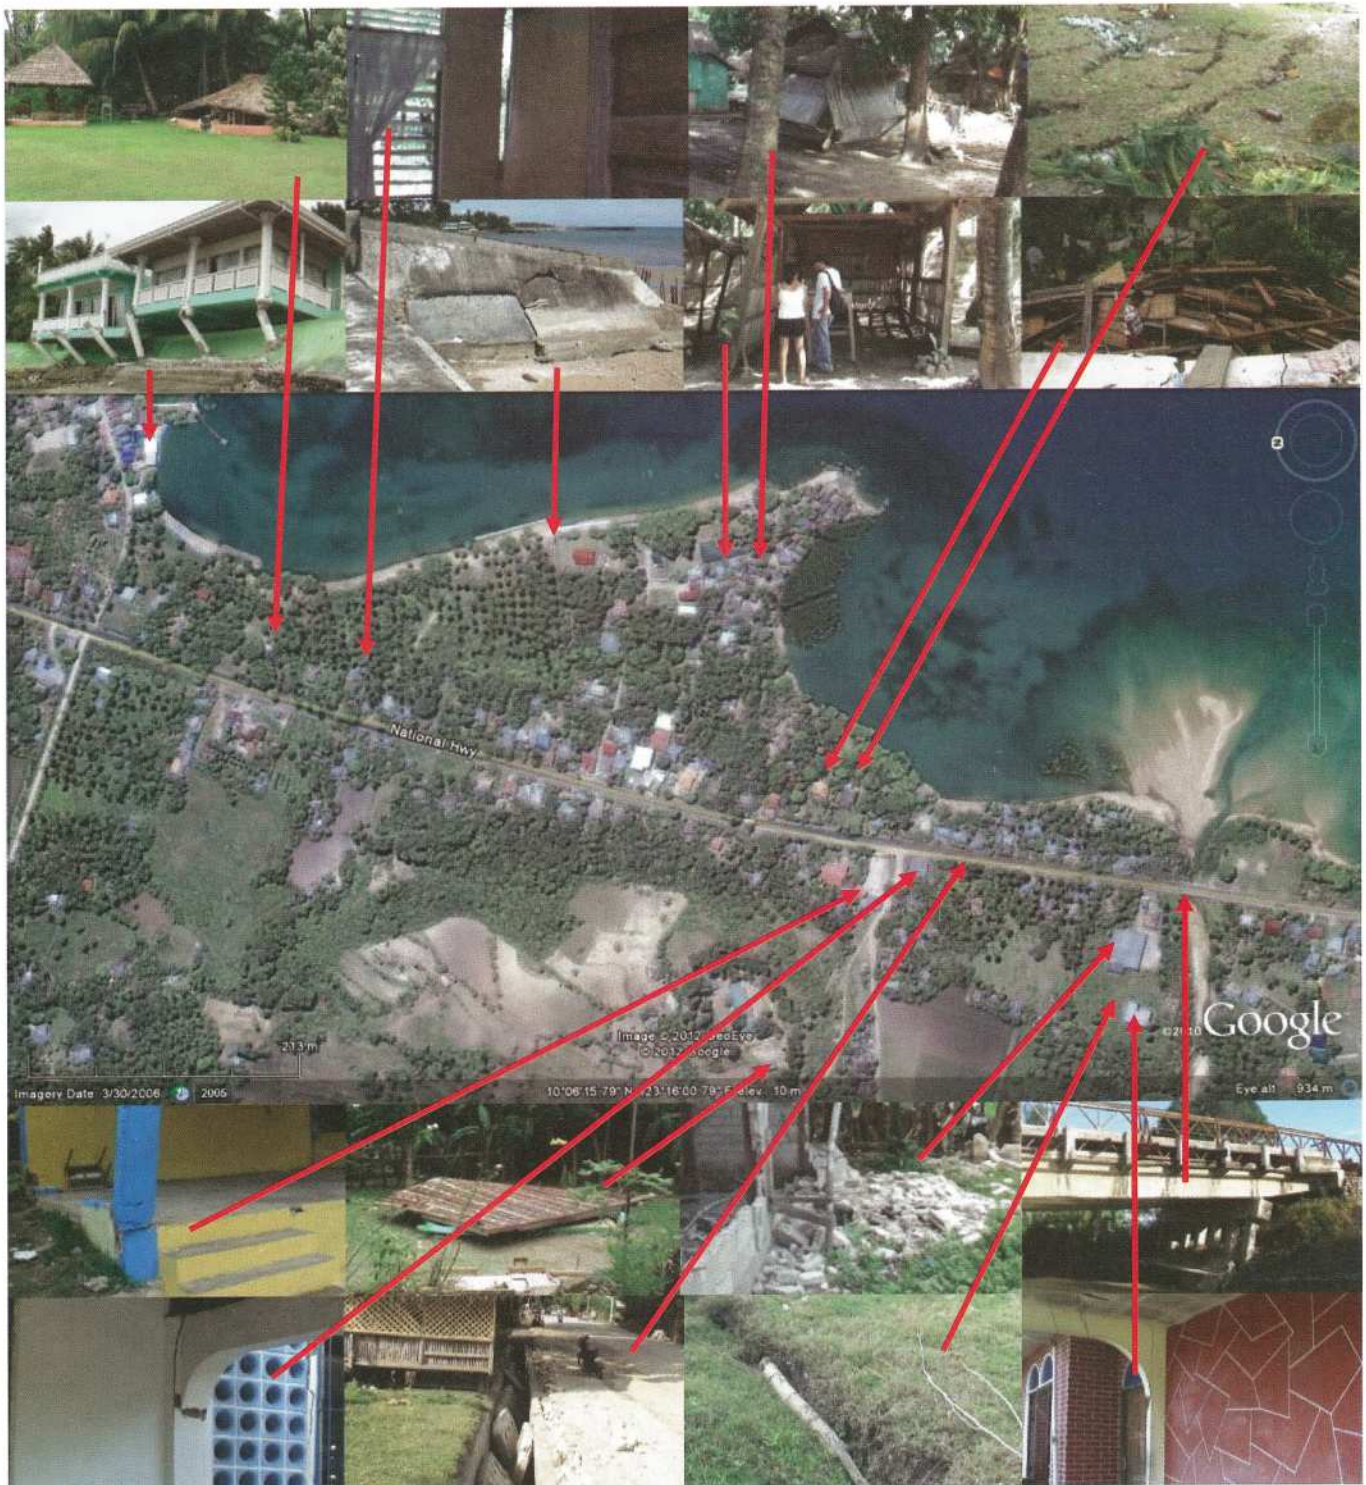
Figure 8. Photos show the damaged man-made structures due to strong ground-shaking inspected at Brgy. Tinayunan Beach, Guihulngan City. Their exact location is shown in the Google image map.

The heavy-roofed barangay community stage sustained shear failure at the base of its slender reinforced-concrete columns and at column-beam joints (Figure 8). It was immediately cordoned-off for safety against possible total collapse in the ensuing aftershocks. The old masonry-wood Chapel along the National Highway sustained moderate to severe damage to its walls and main entrance posing imminent hazard to parishioners. The hillside school stage of the Filomena T. Aranas Memorial Elementary School totally collapsed while five of the schools' buildings sustained slight to moderate structural damage and moderate to severe non-structural damage requiring immediate solutions prior to use as it poses risks to students in the aftershocks and in any future intense earthquake. The damages to roads and to a section of the open pit sewage canal were mainly due to moderate to severe lateral spreading and fissuring.

The damage to Tinayunan Bridge (Km Post) (Figure 8) was mainly due to a combination of shear in the longitudinal direction of the bridge parallel to the shoreline and lateral spreading on both sides of the river. The row of column supports in the north-east end were all sheared at the base and collapsed towards the north-east abutment while the other row of column supports in the south-west end on the other side of the river collapsed towards the south-west abutment. Both abutments were severely damaged by pounding and lateral spreading. The nearby river dike on the south-west end was ruptured at many points along its length while plenty of fissures and uneven ground settlement were found on the approach and fringes of the north-east end of the bridge. These observations at Tinayunan Bridge attest to an intensity of ground shaking not less than PEIS VII.

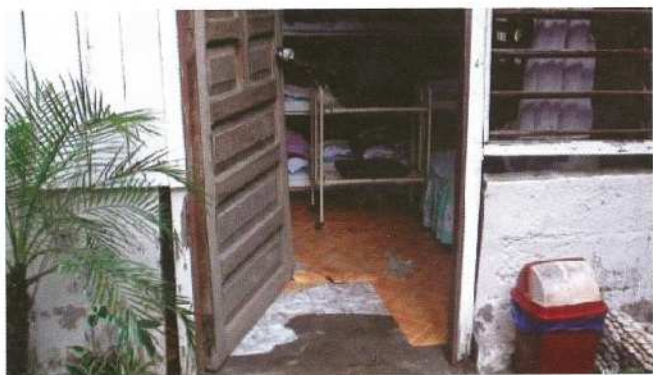
10 A. Inadequate connections at wood-masonry joints

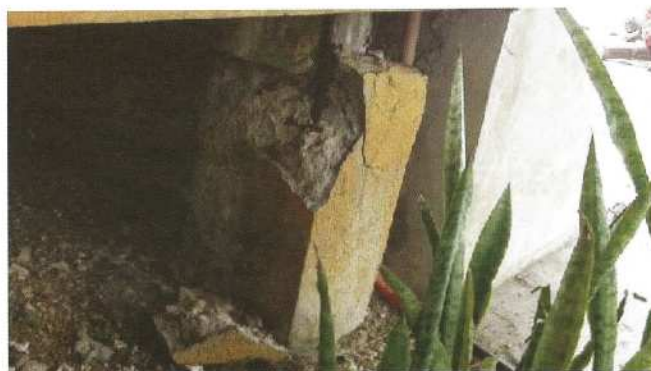
10 B. Rupture at concrete pedestal-wooden post connection

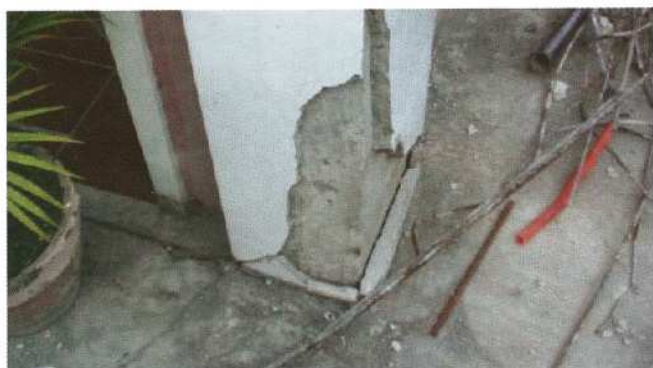
10 C. Column plaster normally spalled by high-intensity shaking

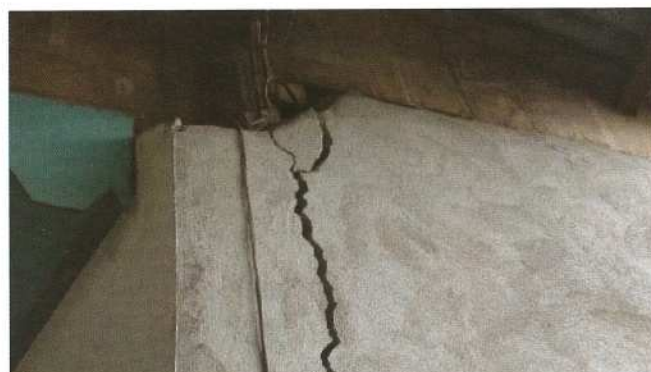
10 D. Typical column-wall joint failure due to insufficient dowelling

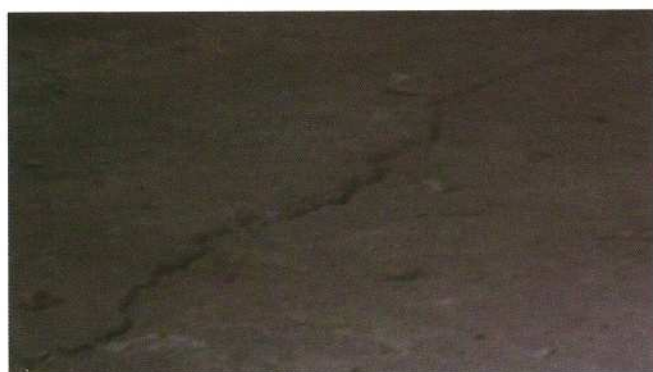
10 E. Concrete slab cracks lacking adequate reinforcements and anchorage

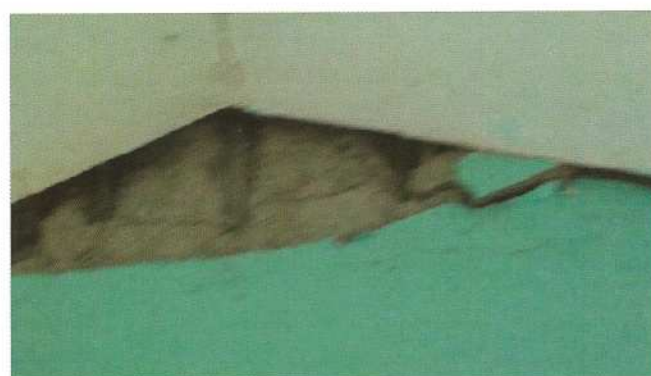
10 F. Hazard posed by gable walls already weakened by the main shock

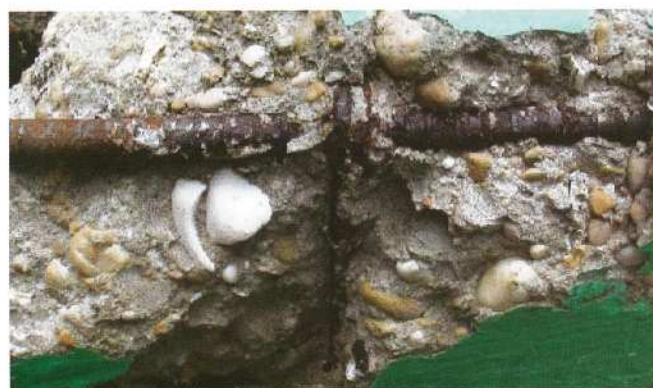
10 G. Corrosive effect on re-bars of beach sand and gravel aggregates

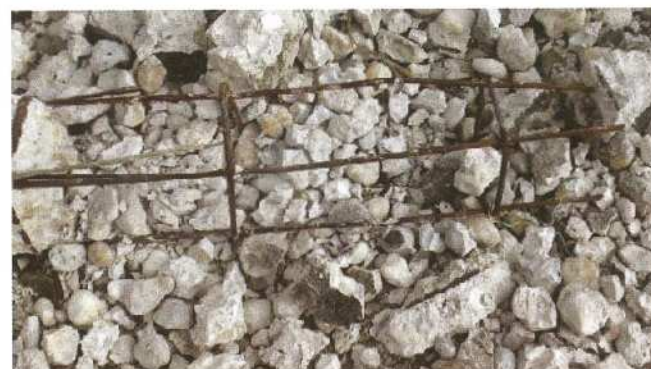
10 H. Inadequate quality and quantity of re-bars and concrete mix

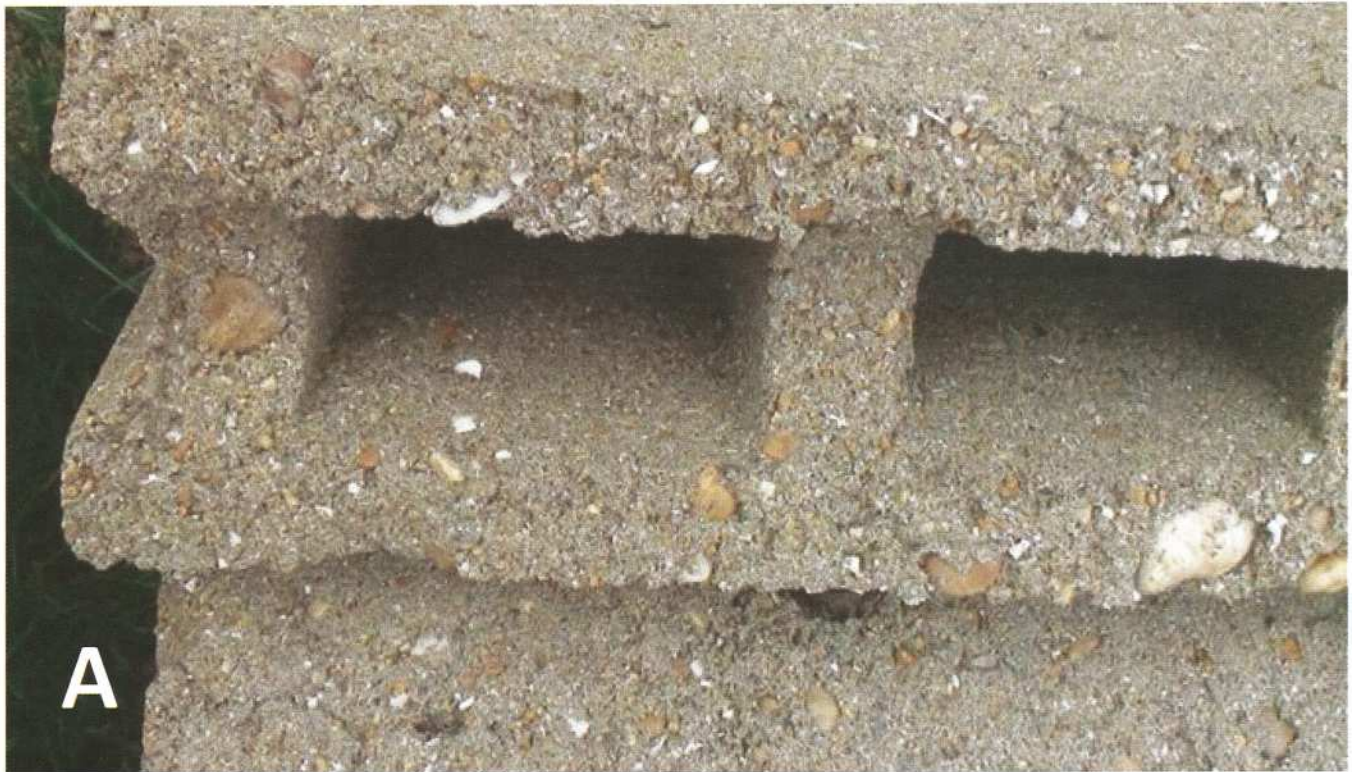
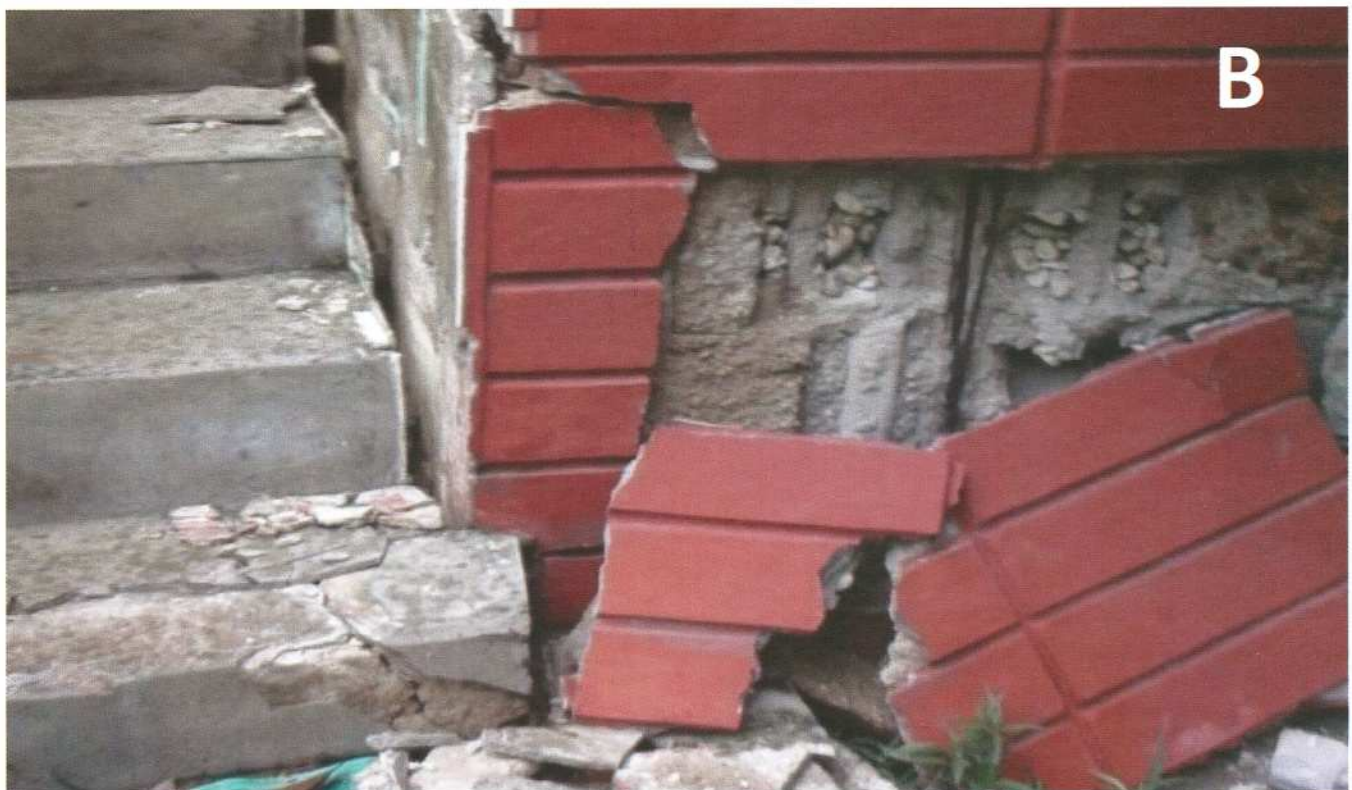
Figure 11. A. Aggregates used for CHB taken from beaches. B. CHB wall showing mortar fillers lacking cement paste for bonding.

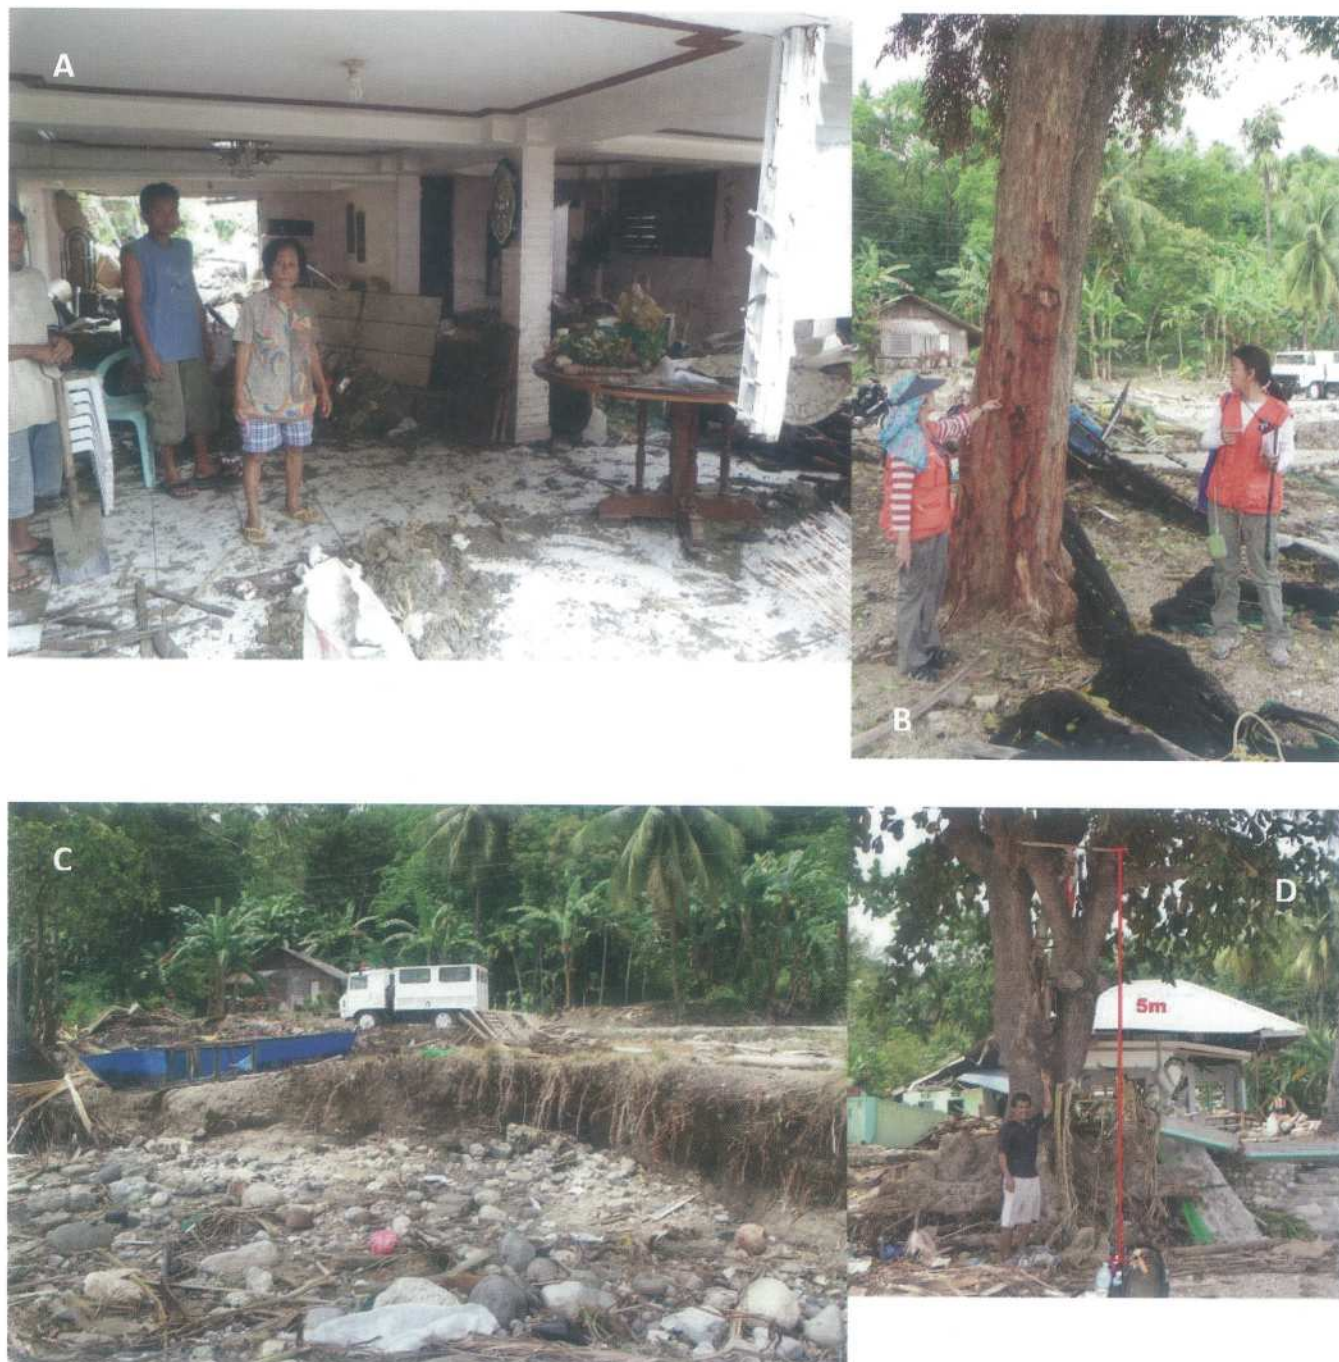
Figure 13. Debris left by the local tsunami that hit the eastern coast of central Negros Island. A. High water marks and sand deposit in a house at Sitio Looc, Bgy. Martilo, La Libertad. B. Abraded bark of a tree at its southeast side. C. Eroded beach face and berm deposit and damaged fishing boat. D. Wave height of 5 m from sea level during time of survey reconstructed from this tree at Sitio Looc, Bgy. Martilo, La Libertad.

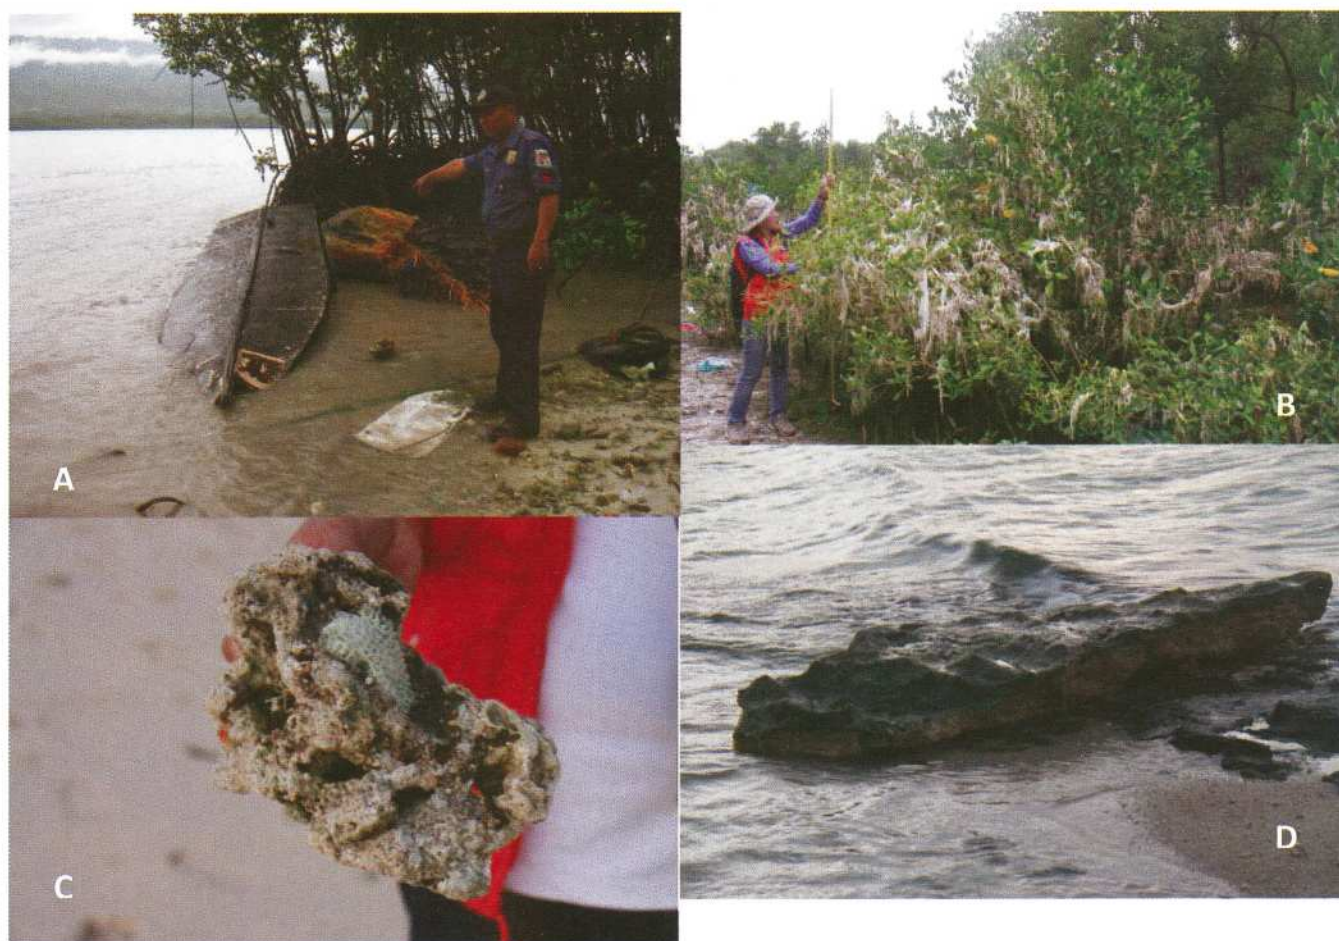
Figure 14. Tsunami impact along the west coast of Cebu Island. A. Overturned and damaged fishing boat at Badian, Cebu. Photo taken few hours after the impact, courtesy of Engr. Nellas of Badian-MPDC. B. Tsunami debris including sea weeds strewn amongst the mangroves show the approximate wave height. About 2.2 m of wave height was measured at Barangay Poblacion West, Moalboal. C and D. Cobble- to boulder-sized coral fragments that was transported as far as 20 m inland by the tsunami.

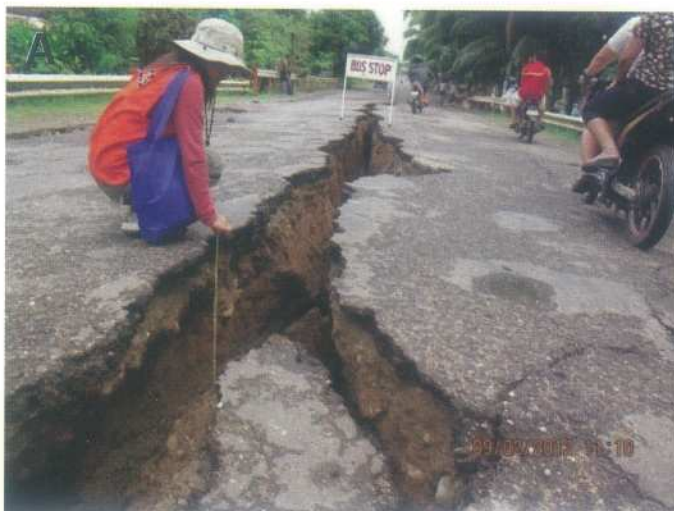
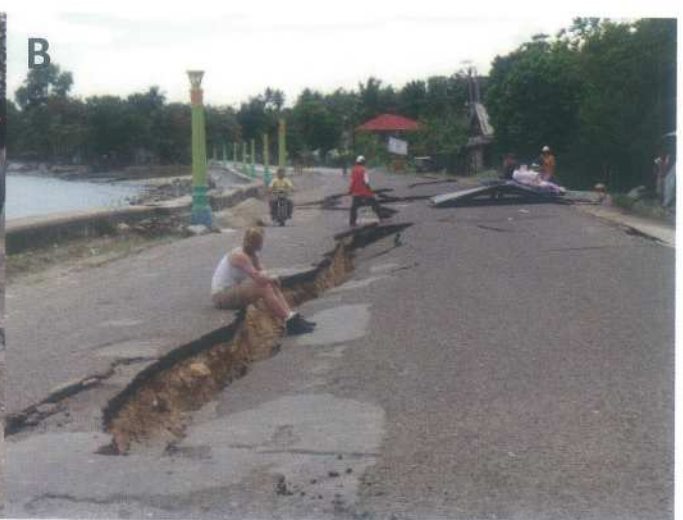
roads producing fissures parallel to them. Fissures along the stretch of the highway in Jimalalud and Guihulngan extend approximately 250 to 500 meters and are up to half meter wide and 2 meters deep (Figure 18 A and B). The most extreme lateral spread combined with ground undulation and subsidence occurred along the approach of Tuway Bridge, affecting ~100 m stretch of the road with terrace-like fissures as high as 1.3 m and opening as wide as 1 m, and subsidence as large as >3m (Figure 19). Along banks of small creeks and rivers, fissures and terrace-like ground-failure damaged concrete river dikes and fences along the banks. Lateral spread along a road in Bgy. Taluyong, La Libertad, situated between a creek and irrigation canal, has an opening of 70 cm. Witnesses reported the breaching of the irrigation canal diverting the water to flow across the concrete road towards the creek. Many bridges also suffered from loss of bearing capacity caused by ground settlement and lateral spreading. Bridge footings tilted, abutments and road approaches were fractured and settled. Two bridges, the Pangaloan Bridge and Martilo Bridge (Figure 20), suffered from span collapse and were rendered temporarily impassable for days, isolating the towns of Jimalalud, La Libertad, and Guihulngan and caused starvation and fear among the residents. Buckling of the roads and residential areas were also very evident in the towns of La Libertad and Guihulngan. Measured vertical displacements of buckled roads range from 15 to 59 cm.

Figure 18. Intermittent lateral spreading affected 250-500 m stretch of the National Highway in Negros Oriental. A. Fissures parallel to a segment of the highway just north of Jimalalud Bridge were as deep as 2 m, and B. Step-like fissures and undulation along the highway in Guihulngan City Poblacion.

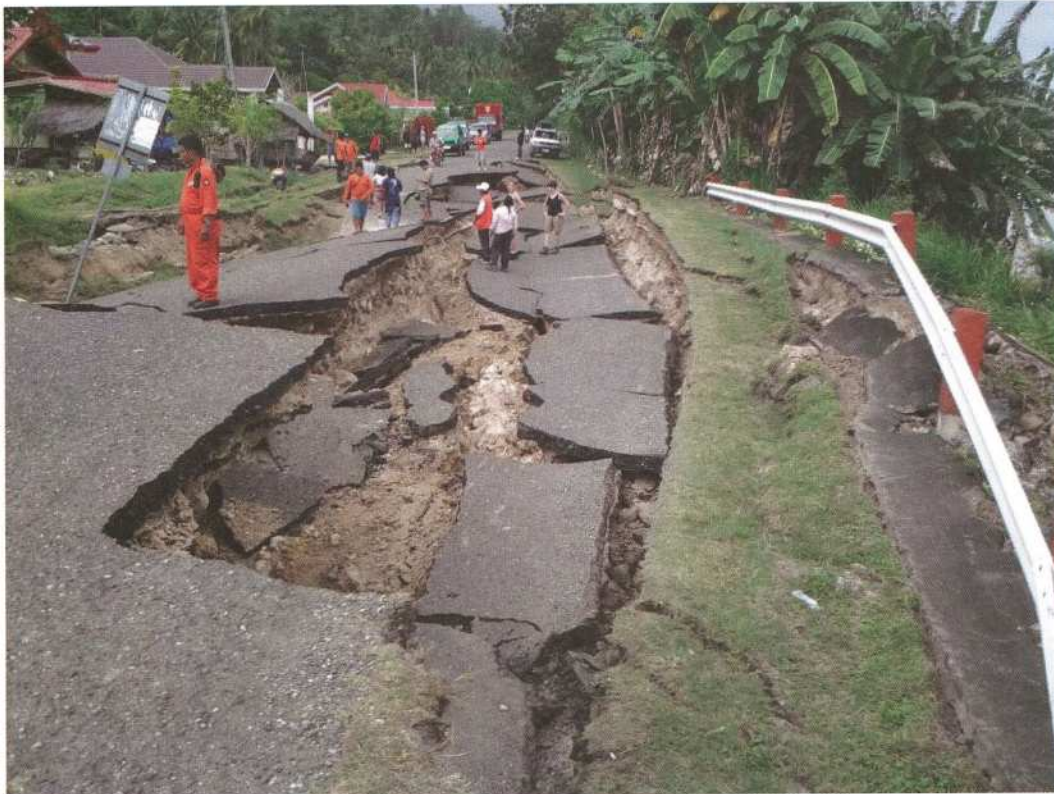
Figure 19. Broken and dislocated asphalt road near the section of Tuway Bridge in Guihulngan City due to lateral spreading, undulation and ground subsidence.

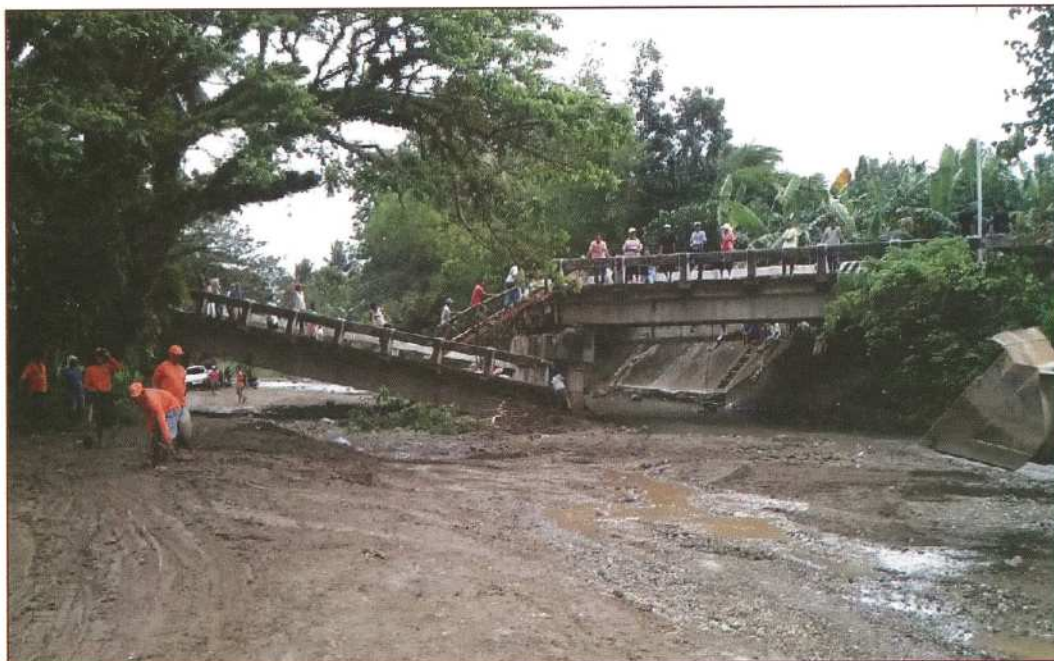
Figure 20. Loss of bearing capacity due to lateral spreading along river banks resulted to span collapse of some bridges like Pangaloan Bridge in Jimalalud. This rendered some bridges to be temporarily impassable for days.

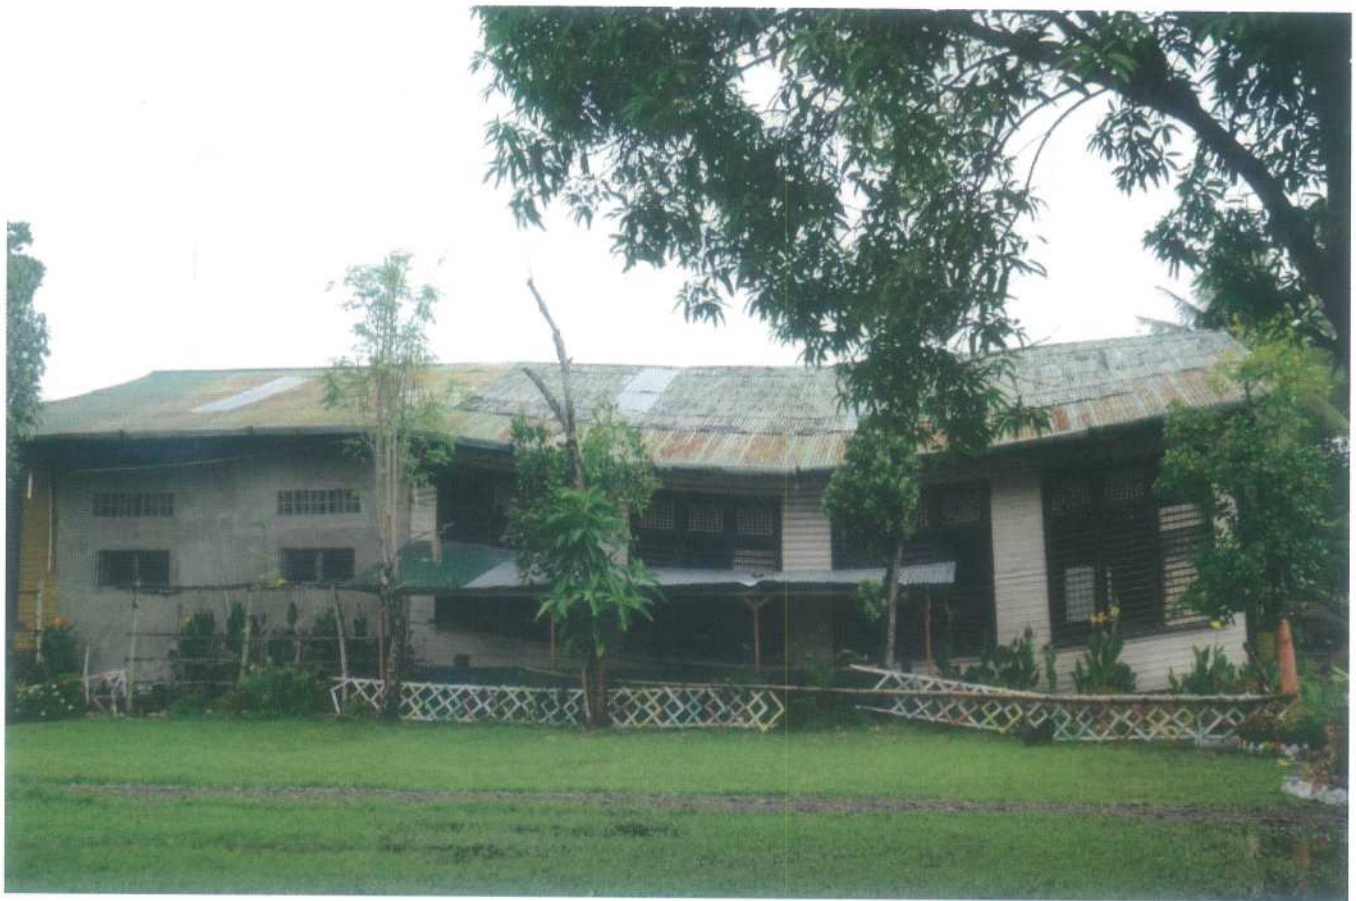
Figure 21. Ground undulation exhibited on one of the school buildings of Ayungon Elementary School.

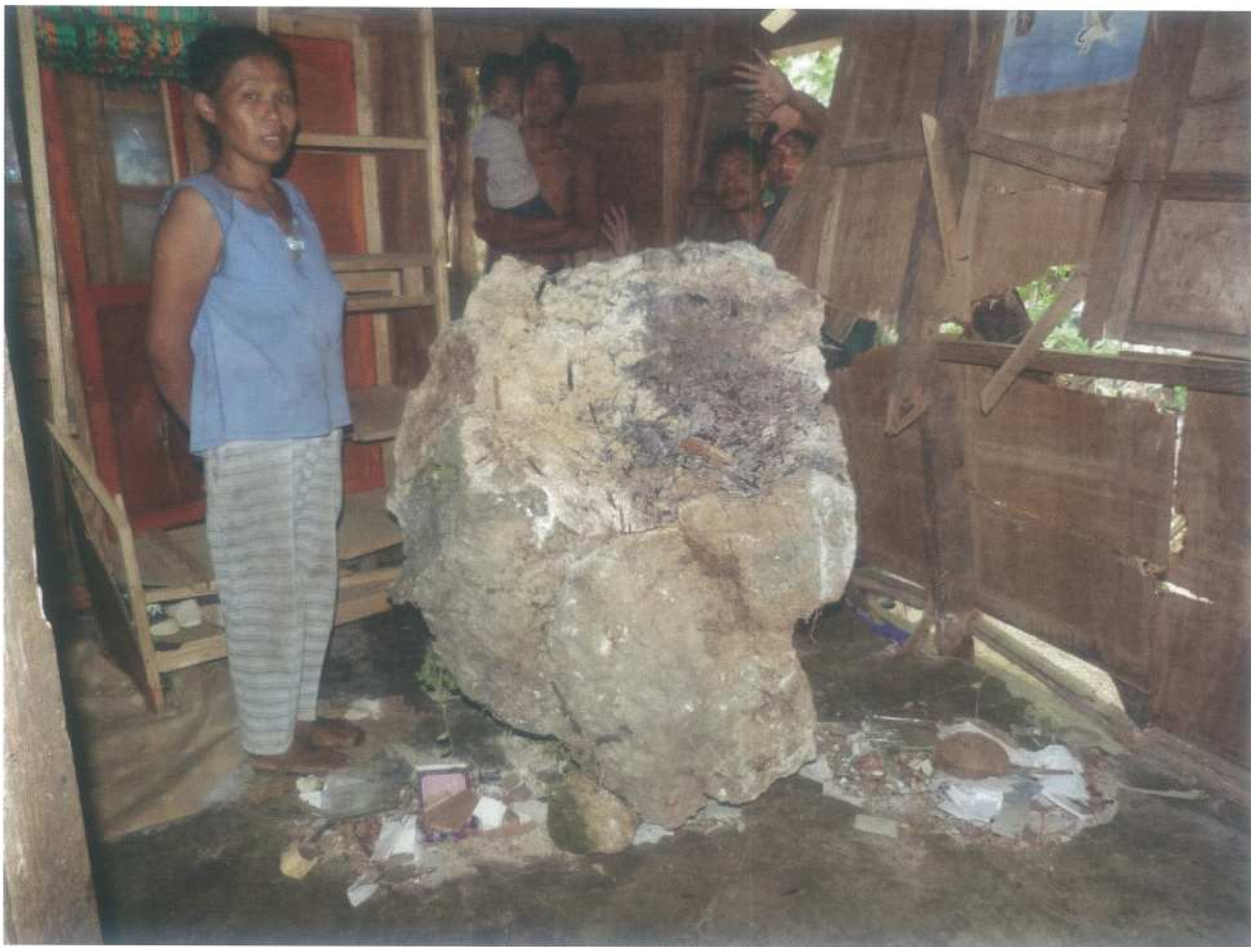
One of the notable case of slope failure was a roadside rockslides in Brgy. Dampa, Guihulngan, where a large limestone block measuring ca. 1 m in diameter rolled and smashed into a hut along the way (Figure 28). Several other large, shallow to deep-seated landslides were found along river valleys. These were mostly failures in deep soil or highly weathered rocks along the steep walls of the V-shaped river valleys. None, however, was large enough to cause temporary damming of the river channel.

Figure 28. A large limestone block, ca. 1 m in diameter, from a rockslide in Brgy. Dampa, Guihulngan City rolled and smashed into a hut along the way.

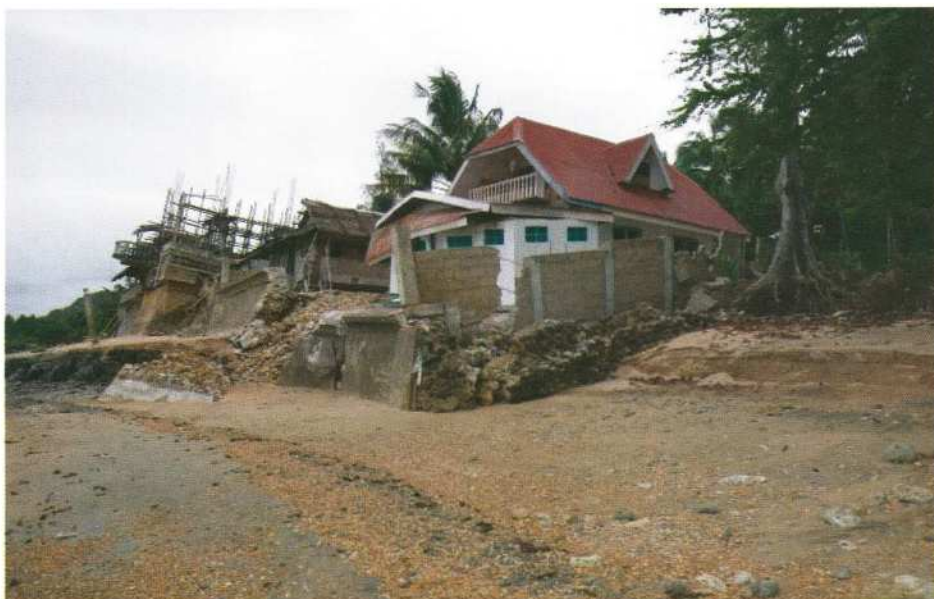
Coastal uplift and deformation were observed in the barangays of McKinley and Tinayunan Beach in Guihulngan City. At least four concrete houses along the beach were damaged and tilted higher than the surrounding surfaces (Figure 29). One resident, Sgt. Emmanuel Mendoza described that his house was "uplifted" or raised after being "pushed in" from the sea. He further indicated that there was no steep beach face before the earthquake but simply a gentle beach face composed of calcareous sand. After the

Figure 29. Four houses fronting the beach in Bgy. McKinley, Guihulngan City that were damaged and tilted due to buckling and uplift along the coast.

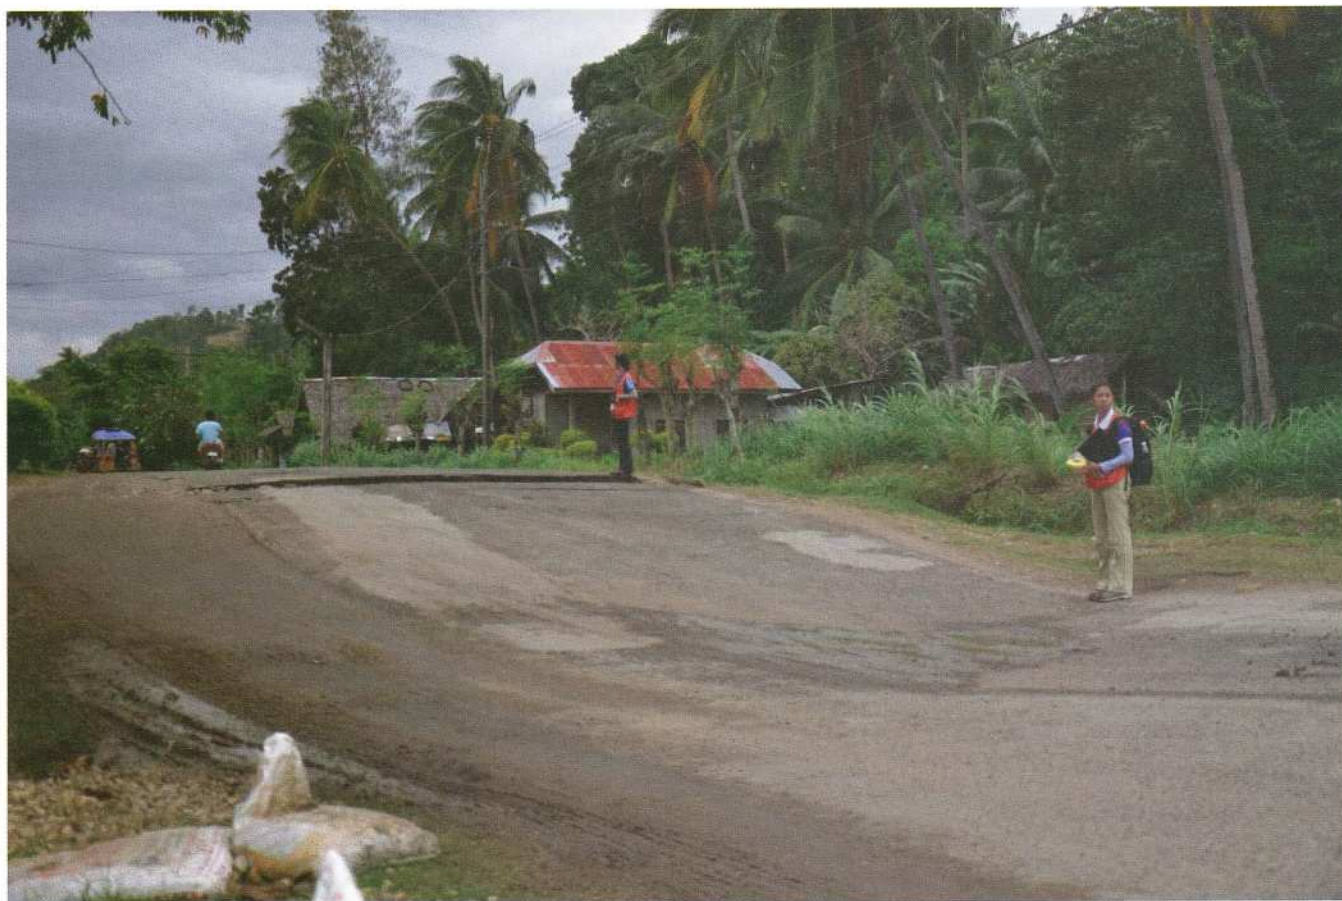
Figure 32. Ground undulation exhibited in a section of the highway adjacent to the uplifted beach in Bgy. McKinley, Guihulngan City. Wave axis is perpendicular to the highway (either E-W or NNW). The wavelength was measured at ~10m and amplitude is ~21cm.
