THE 10 FEBRUARY 2017 MAGNITUDE 6.7 SURIGAO DEL NORTE EARTHQUAKE

2017 M6.7 Surigao del Norte Earthquake PHIVOLCS Quick Response Team (QRT)

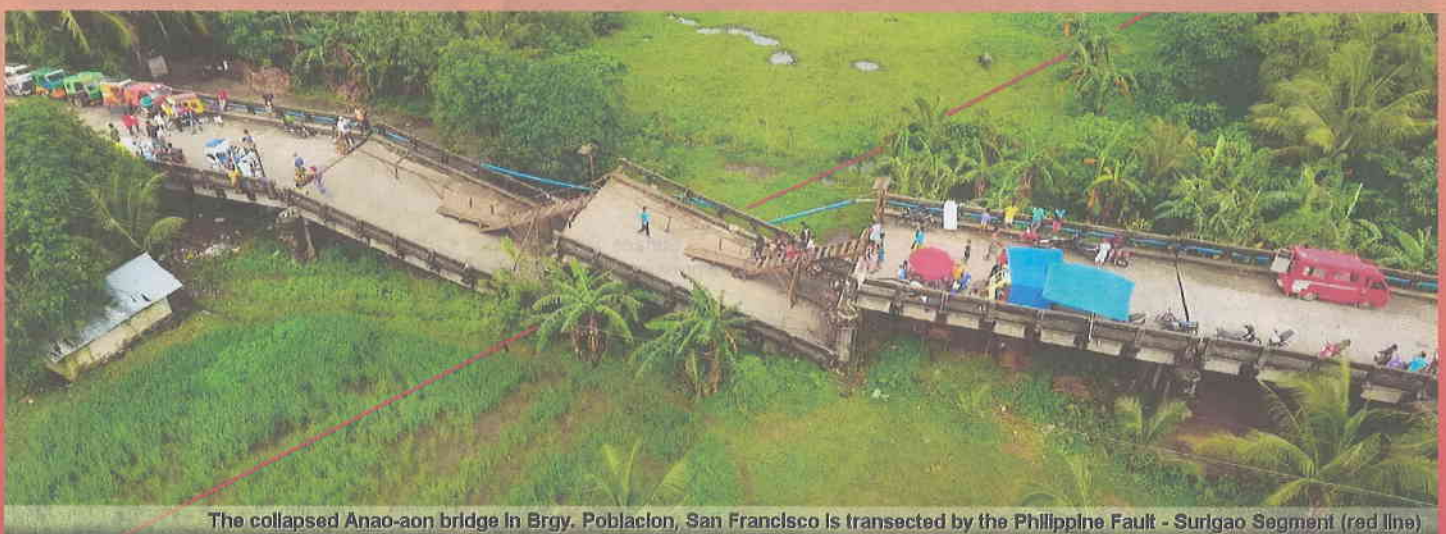
The collapsed Anao-aon bridge in Brgy. Poblacion, San Francisco is transected by the Philippine Fault - Surigao Segment (red line)

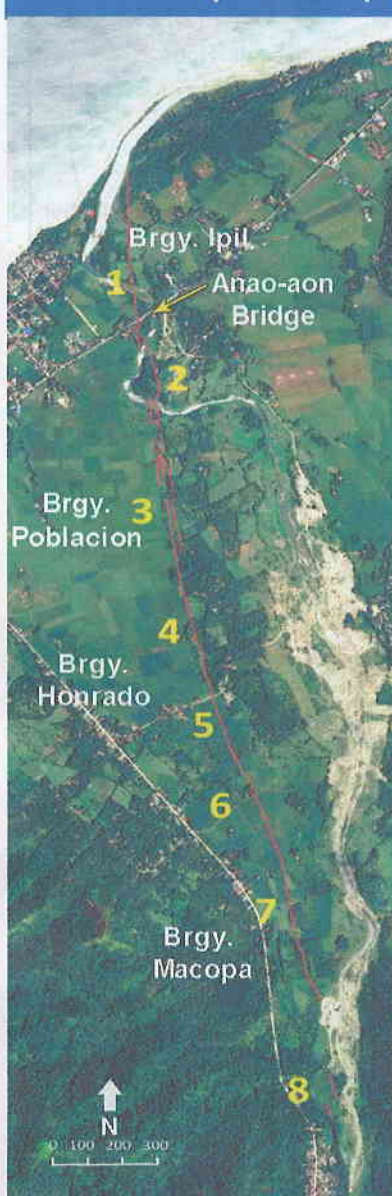
Surface Rupture Map

The Philippine Fault - Surigao Segment, a NNW-SSE trending left-lateral strike-slip fault, generated the 2017 M6.7 Surigao del Norte Earthquake. This event produced a 4.3-km long surface rupture on land that was mapped in Brgy. Ipil in Surigao City and Brgys. Poblacion, Honrado and Macopa in the Municipality of San Francisco, SDN. These barangays were estimated to have experienced a strong ground shaking at PEIS VIII (very destructive). The surface rupture manifested as open cracks and scarps with maximum horizontal and vertical displacement of 60 cm and 40 cm, respectively. The mapped surface rupture is mainly characterized by right-stepping en echelon faults. In some areas, two parallel faults were mapped producing a linear depression. The surface rupture also follows along or near the existing fault scarps produced from previous strong earthquakes generated by the Philippine Fault - Surigao Segment.

- Surface Rupture
- ↗ Red arrows indicate location of fault and direction of displacement
- 1 Number on the map corresponds to the location of the photo

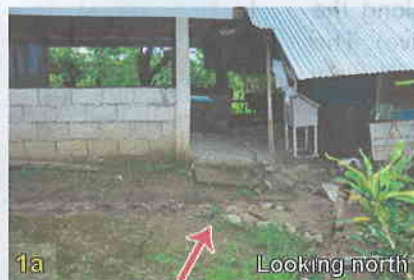
A chapel in Brgy. Ipil, Surigao City, SDN transected by the active fault

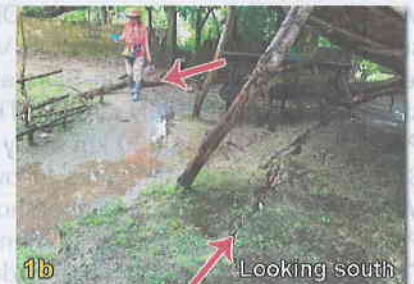
Two parallel fault traces forming a depression

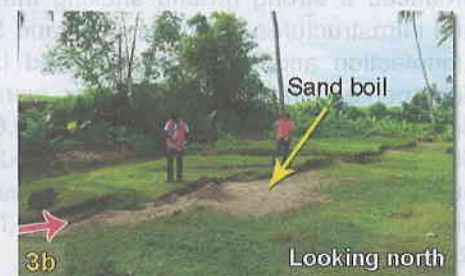
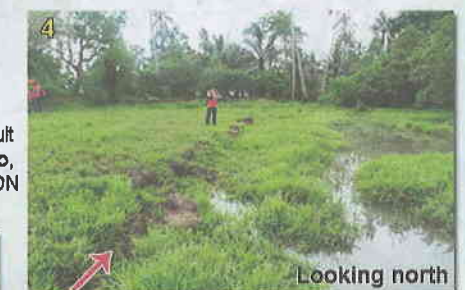
West-facing (3a) and east-facing (3b) scarps of surface rupture. Sand boil also coincides with the surface rupture in Brgy. Poblacion, San Francisco, SDN

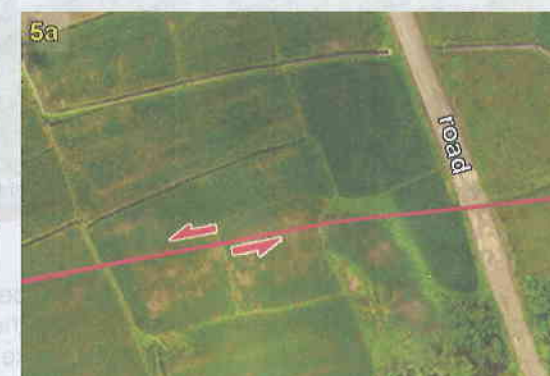
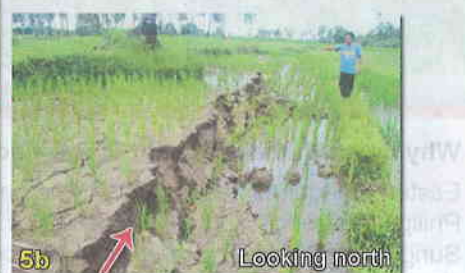
Aerial photo (5a) of rice paddies and road displaced to the left in Brgy. Honrado, San Francisco, SDN. About 30 cm horizontal (5a) and vertical (5b) displacement on rice field

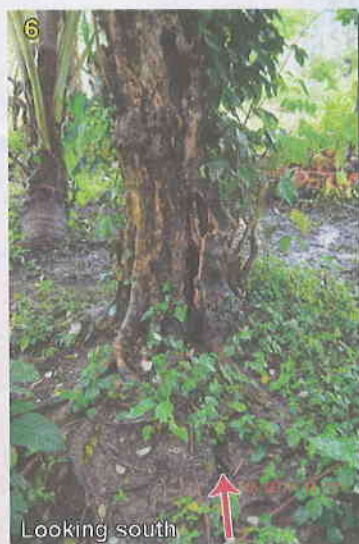
A tree in Brgy. Honrado, San Francisco, SDN transected by the active fault

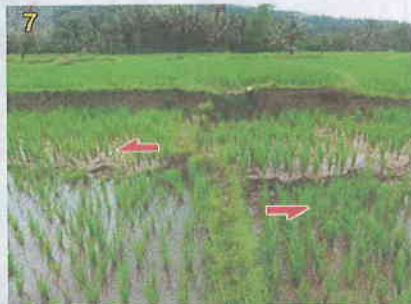
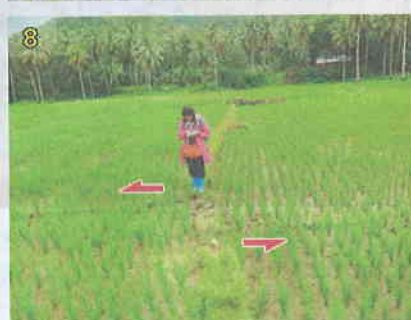
About 20 cm left-laterally offset rice paddies in Brgy. Macopa, San Francisco, SDN (photos 7 and 8)

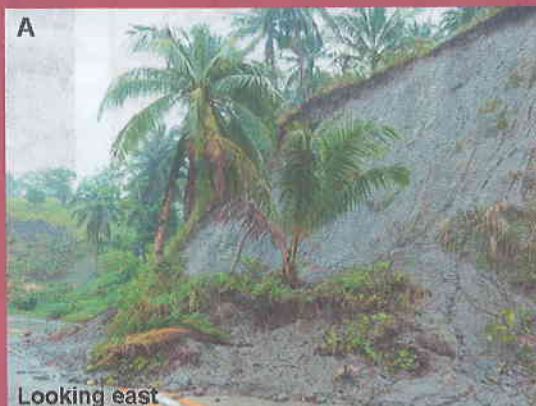
Shallow-seated landslide along Looc - Punta Bilar Road, Surigao City

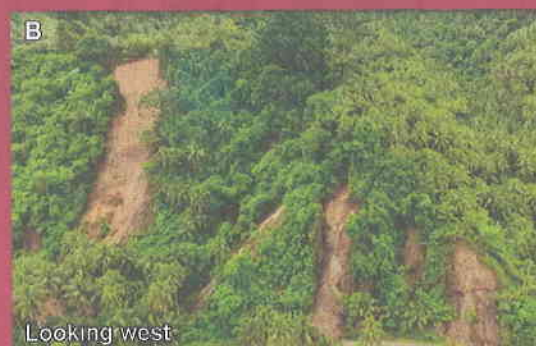
Aerial view of landslides in Brgy. Macopa, San Francisco, SDN

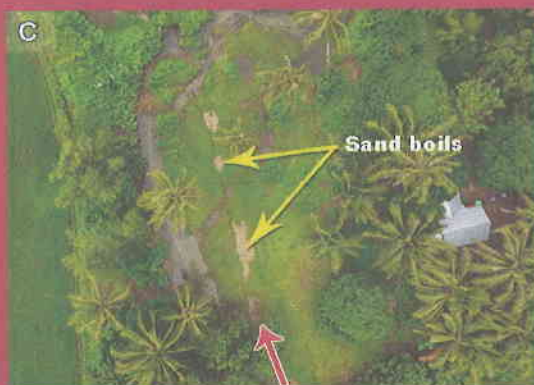
Aerial view of sand boils coinciding with the surface rupture in Brgy. Poblacion, San Francisco, SDN

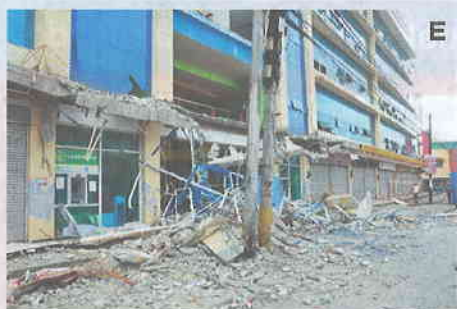
Severely-damaged building of Surigao City State College of Technology

- The best course of action is **preparedness**.
- Damaged buildings and infrastructures should not be used and should be inspected by civil and/or structural engineers.
- Slopes should be checked for tension cracks that may cause landslide during strong earthquake and/or prolonged or heavy rainfall.
- Reconstruction or construction of houses should conform with the National Building Code of the Philippines.
- In case of another felt earthquake, do the **"Duck/Drop, Cover and Hold"**.

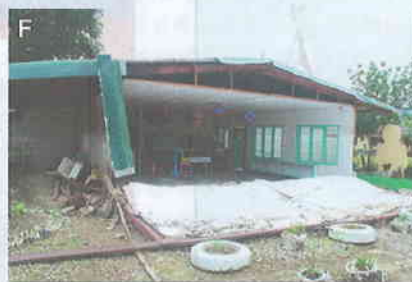
Collapsed wall of Anao-aon Central Elementary School, San Francisco, SDN

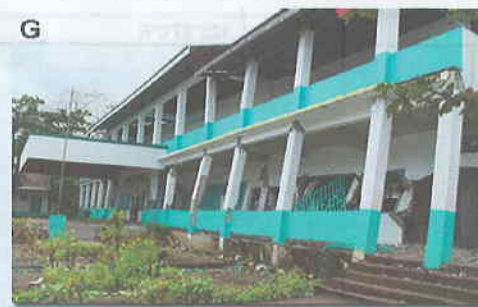
Severely-damaged building of San Nicolas High School, San Francisco, SDN

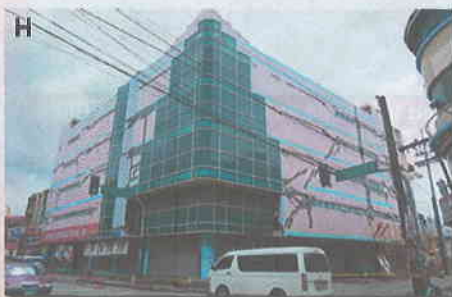
Damaged building of Absolute Essentials Traders Inc. in Surigao City

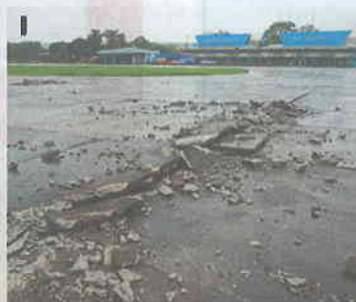
Buckled runway of Surigao Airport
